# The Ladbroke Grove Rail Inquiry

## Part 1 Report

**The Rt Hon Lord Cullen PC**

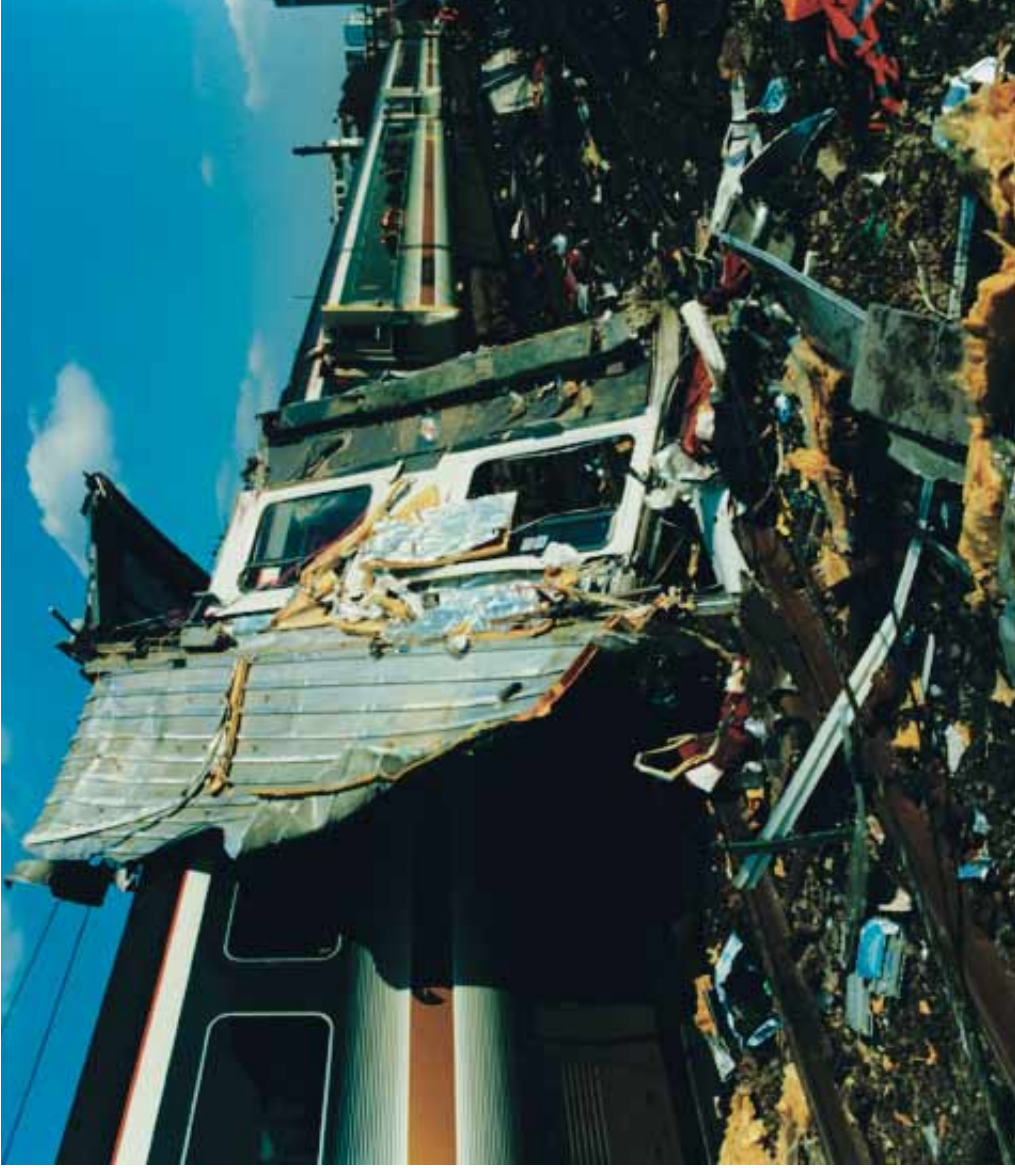
**Plate 7:** Part of the front car of the Thames Turbo against coach B of the HST: view from the west (south side of crash).

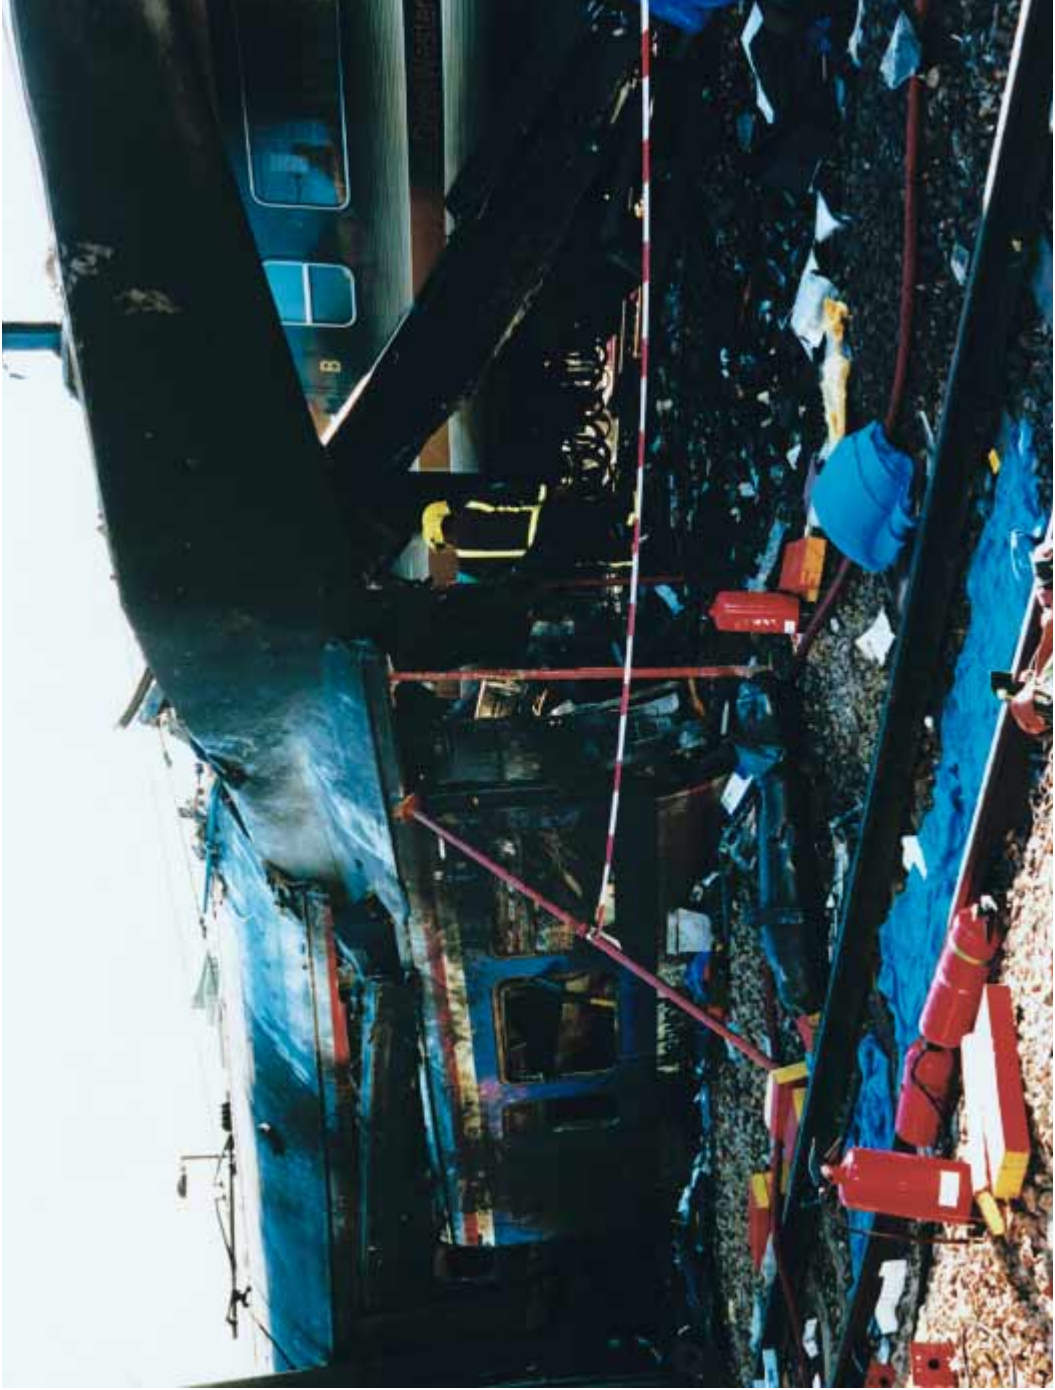
**Plate 8:** Front and middle cars of the Thames Turbo: view from the north.

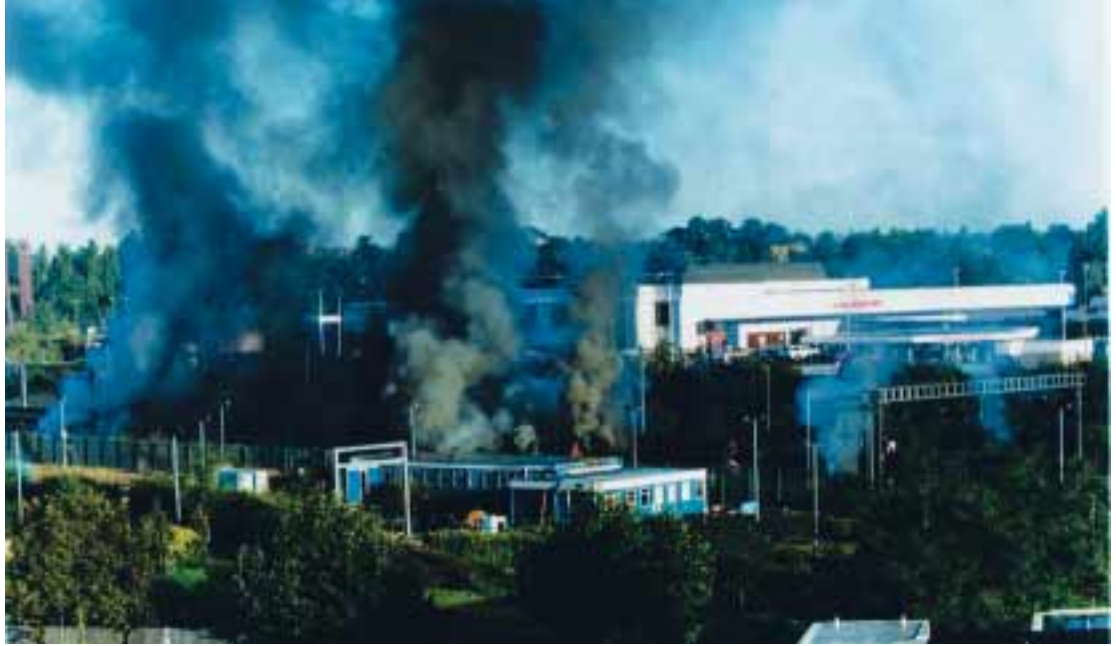
**Plate 9:** Early stage of the fire in coach H of the HST: view from the south.

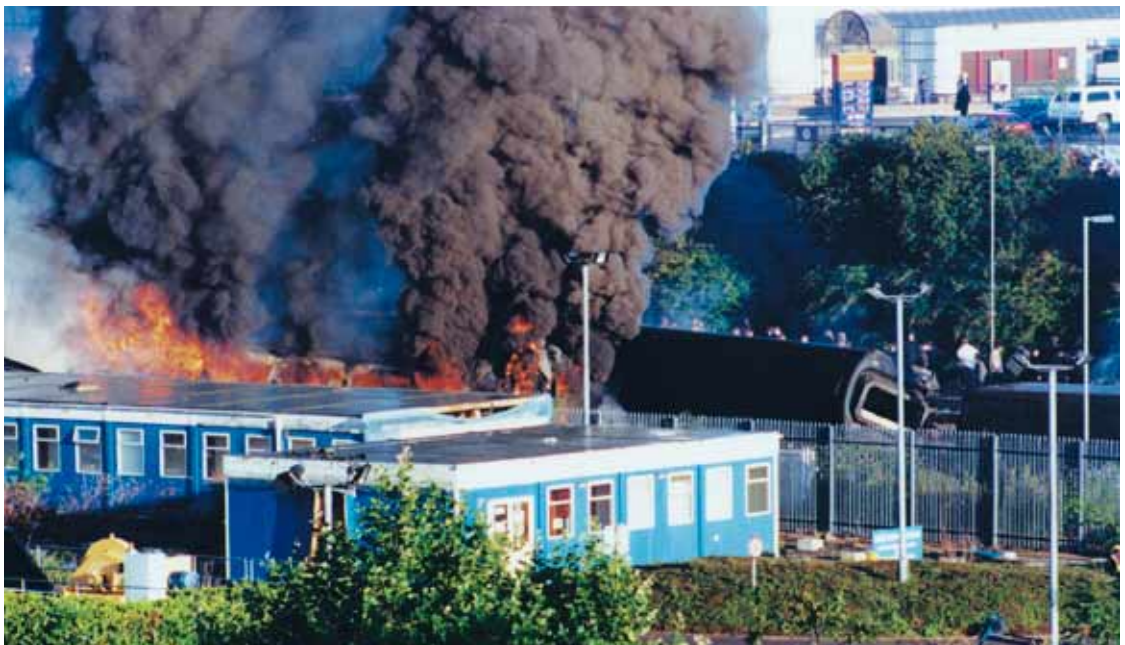
**Plate 10:** Later stage of the fire in coach H of the HST: view from the south.

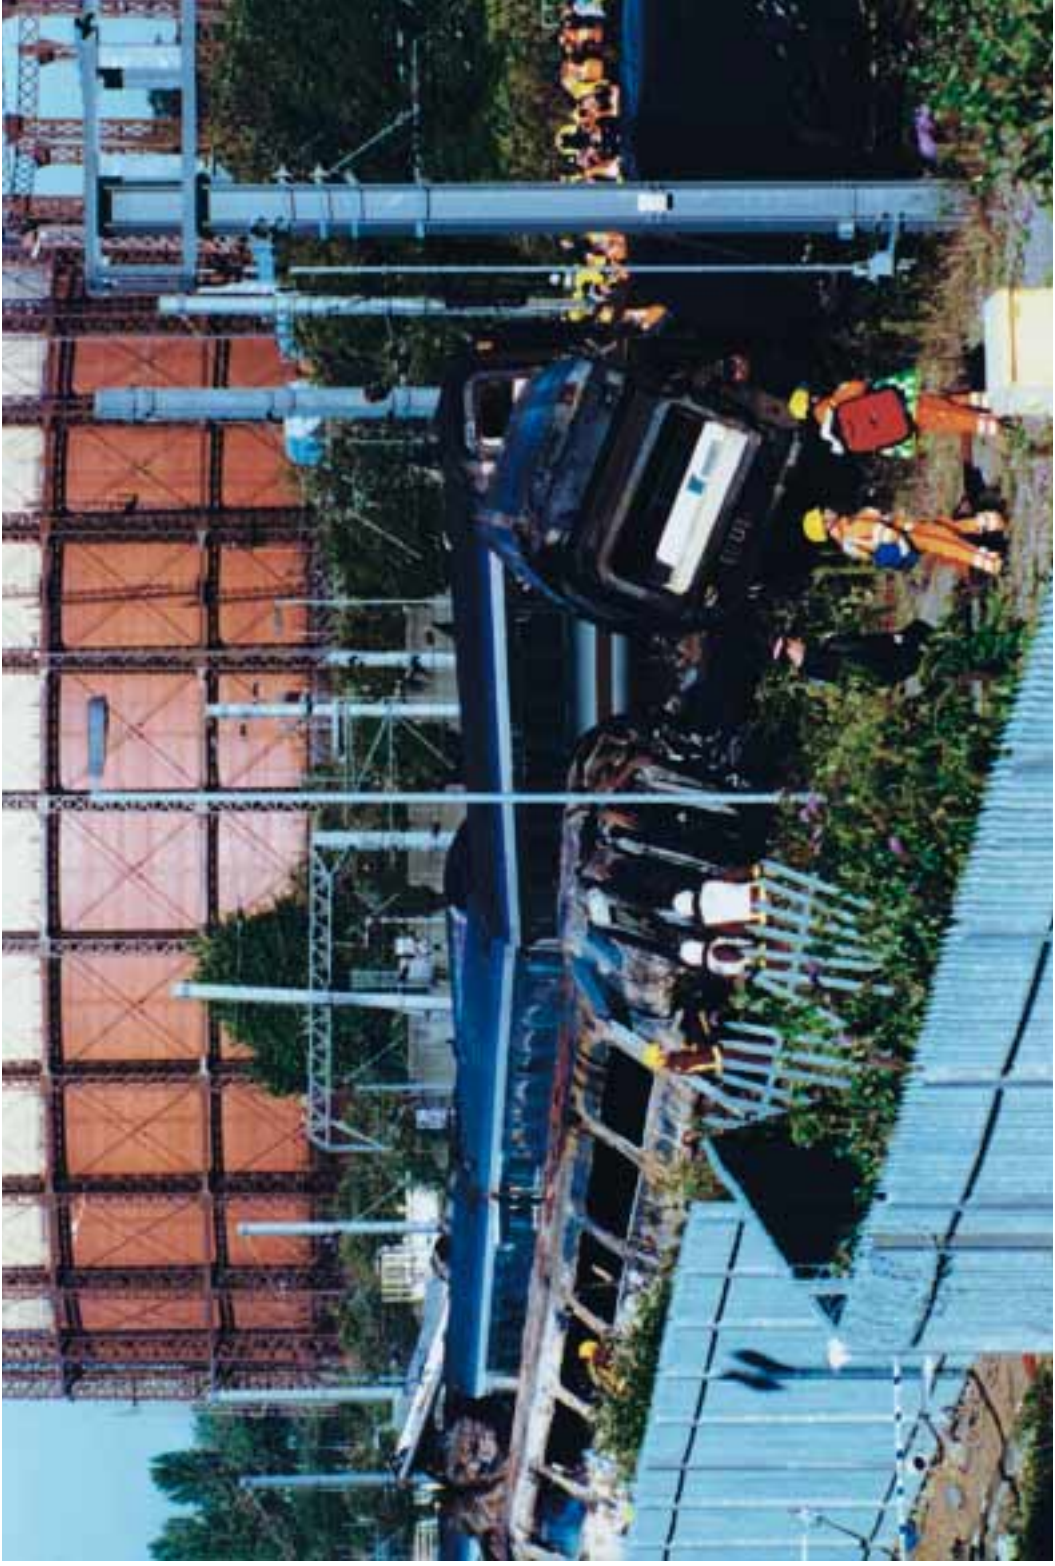
**Plate 11:** Crash site showing coaches F and H of the HST: view from the south-east.

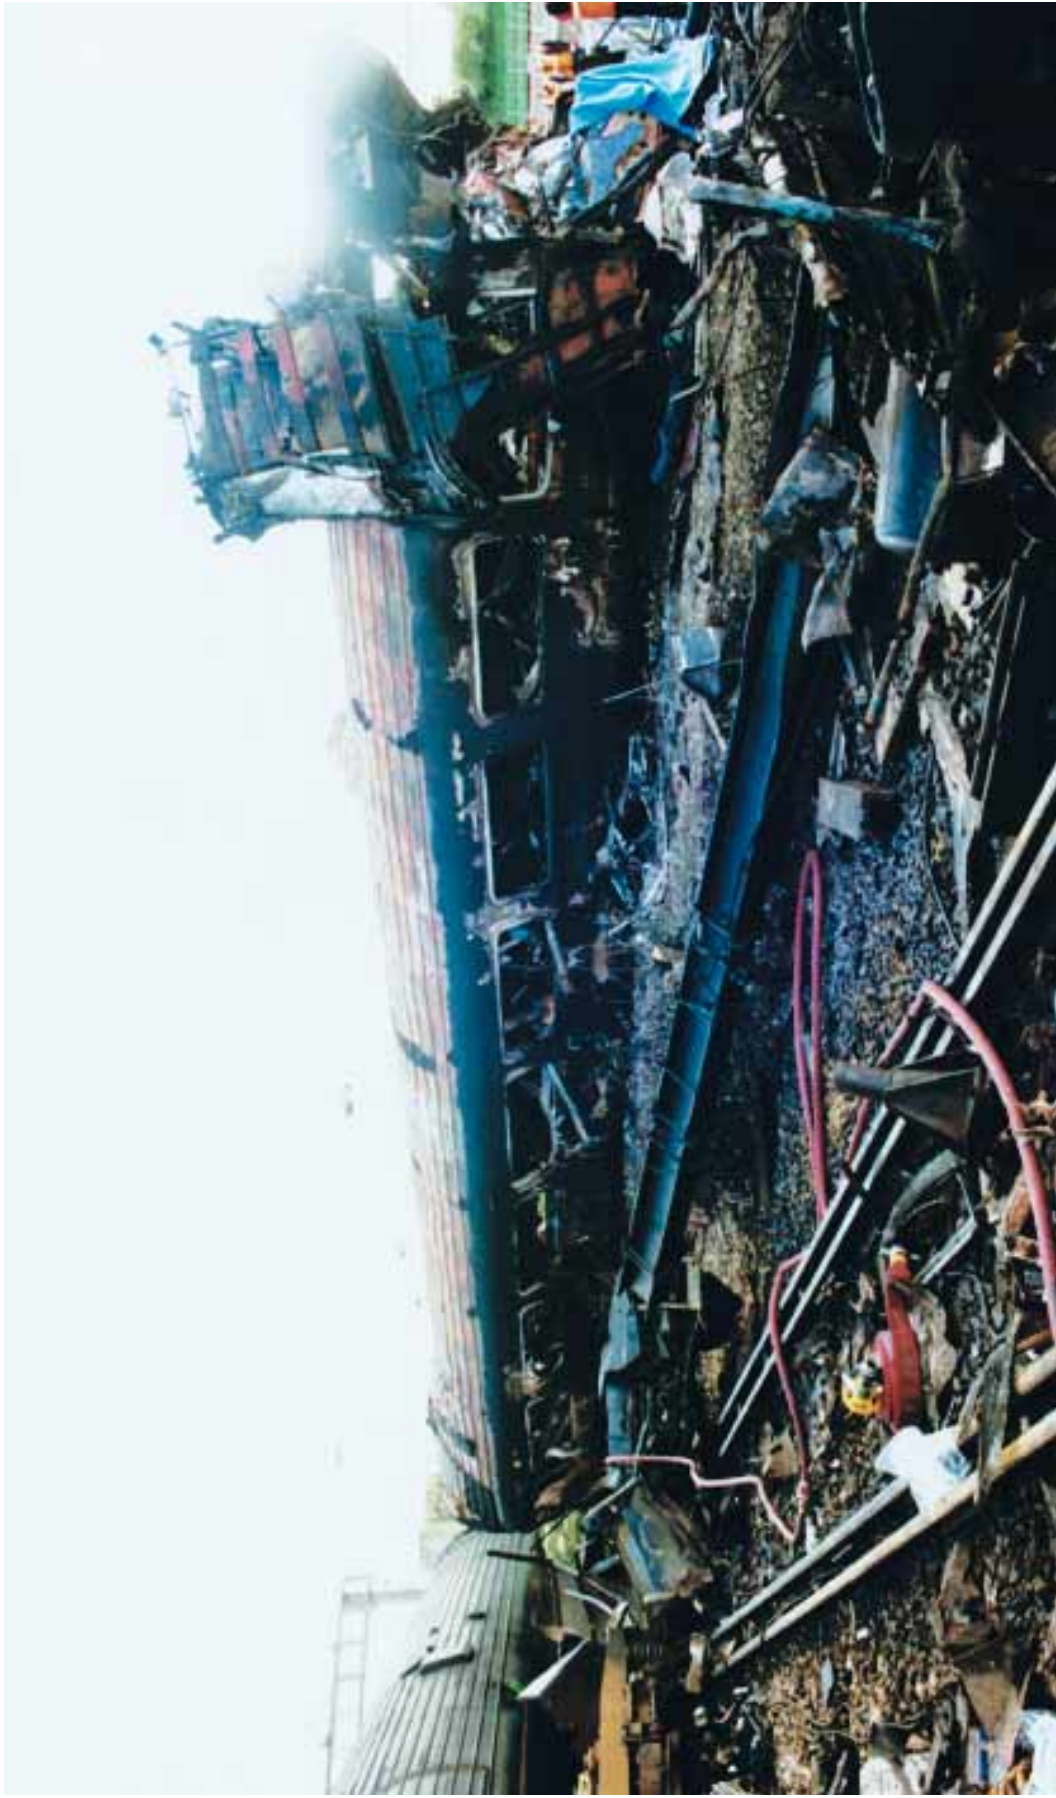
*Plate 12:* Coach H of the HST: view from the west.

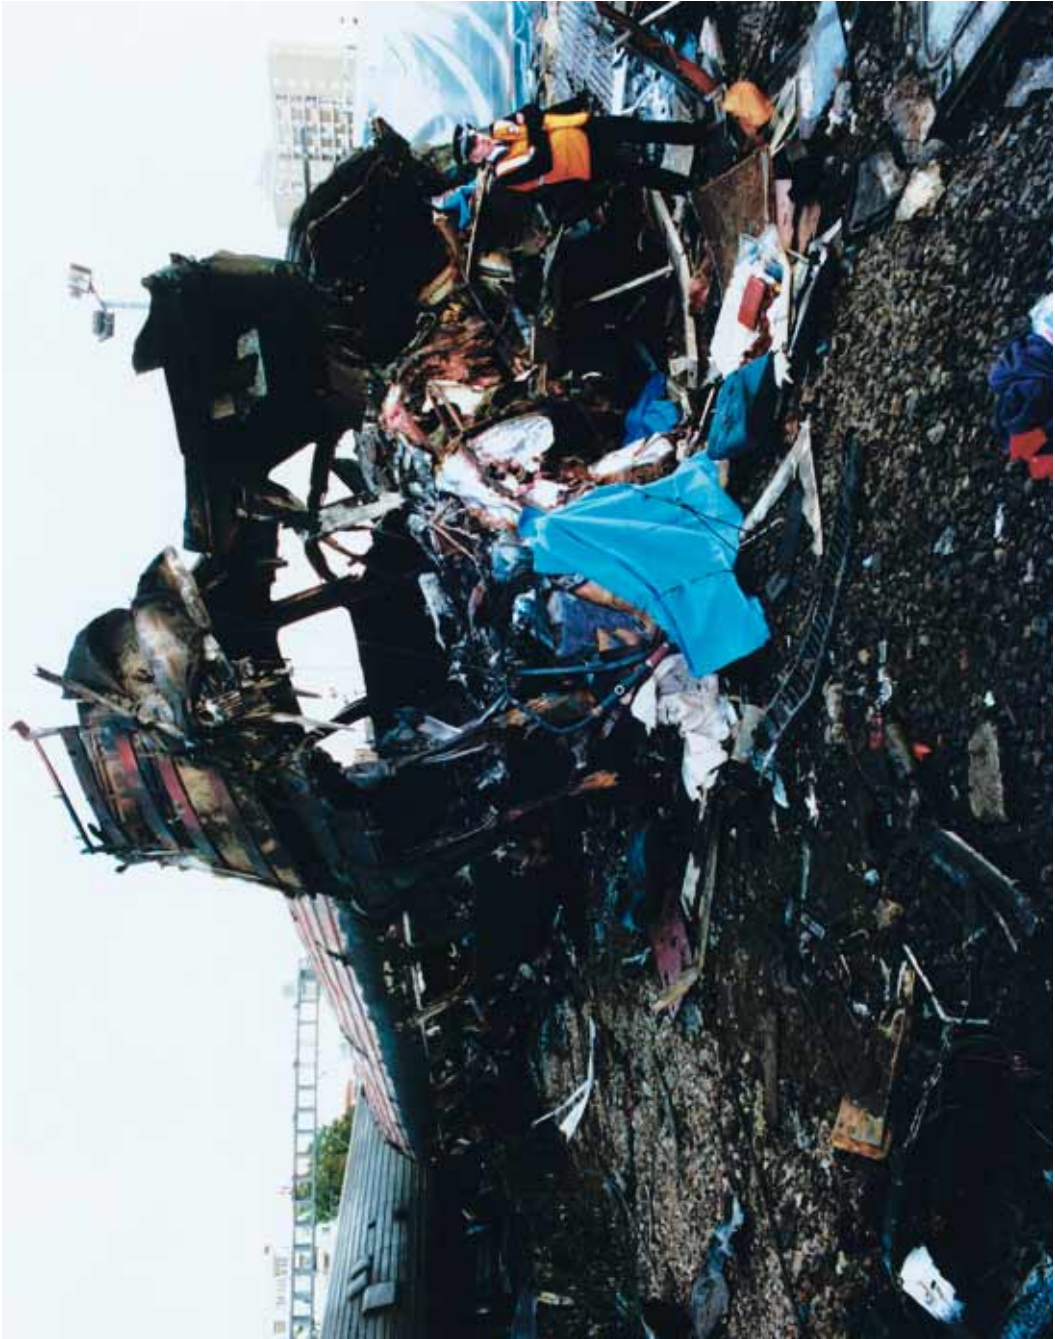
*Plate 13:* Coach H of the HST: view from the west.

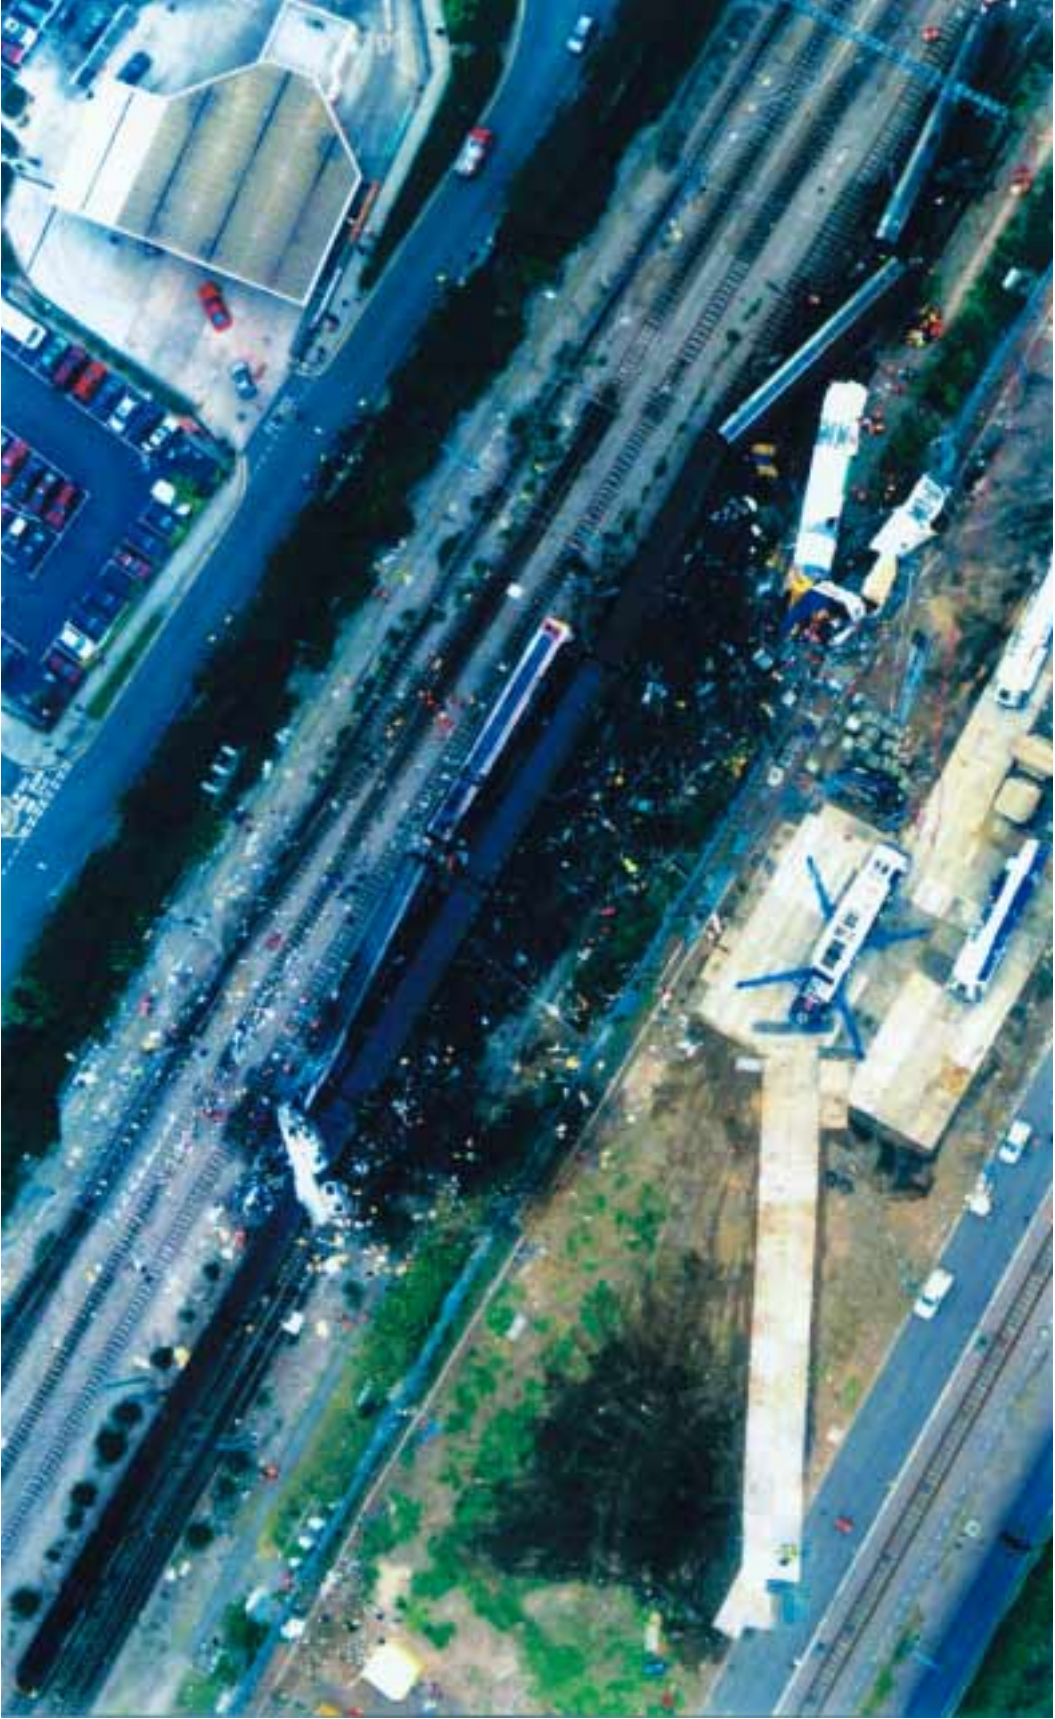
**Plate 16:** Aerial view of crash site taken on 7 October 1999.
